**METALS RESEARCH LABORATORY
CARNEGIE INSTITUTE OF TECHNOLOGY
Carnegie Mellon University**

Investigation of the Plastic Fracture
of High Strength Steels

NASA Technical Report No. 4

October 1972

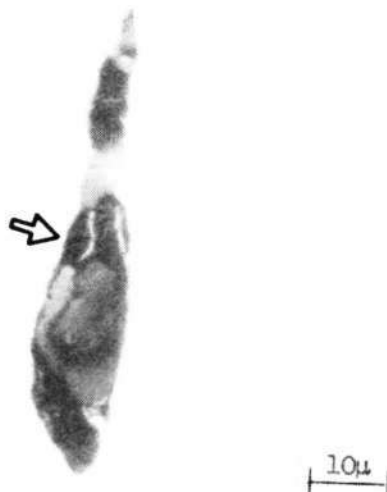
a. Void Initiation by Rupture
of Sulfide-Nucleating
Particle Interface

b. Void Initiation by Fracture
of Sulfide

Figure 8 Examples of Abnormal Nucleation Sites for
Large Voids in AISI 4340 Strained
Plastically (Voids indicated by arrows)

Only occasionally were sites other than the sulfide-matrix interface observed to nucleate the large voids in the AISI 4340 alloys. However, these other nucleation sites (described below) were also always associated with the sulfide particles. Occasionally with very large sulfides containing a large nucleating particle, voids were observed to form by fracturing of the sulfide along the boundary between the sulfide and the interior nucleating particle. An example of this type of nucleation is presented in Figure 8a. Very long, thin sulfides oriented along the tensile axis were sometimes found to be fractured across a minimum section as illustrated in Figure 8b. Neither of these nucleating mechanisms was seen often, but rather the predominate mechanism of sulfide-matrix interface failure provided most of the large void nucleation. It should also be

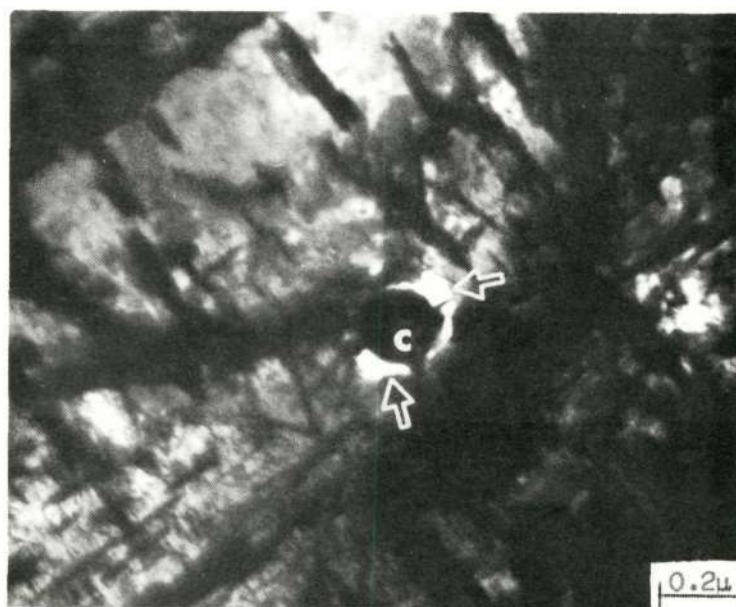
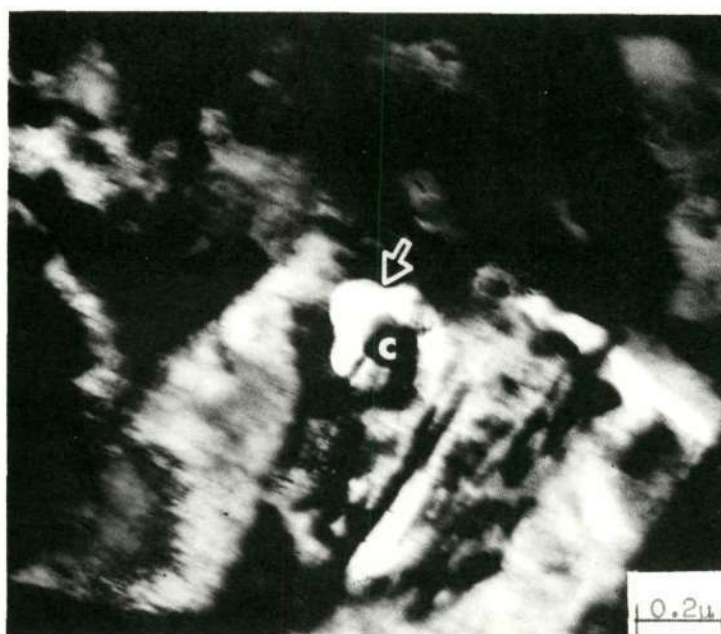
Figure 9 Void Initiation by Decohesion of Carbide-Matrix Interfaces in AISI 4340 Plastically Strained (Arrow indicates void and "C" indicates carbide)

Evidence was found that the small voids are nucleated by decohesion of the carbide-matrix interface. Figure 9 presents two observed examples of voids formed at carbide interfaces. The voids are indicated by the arrows and the carbides by the letter "C". Selected area electron diffraction confirmed these particles to be cementite.

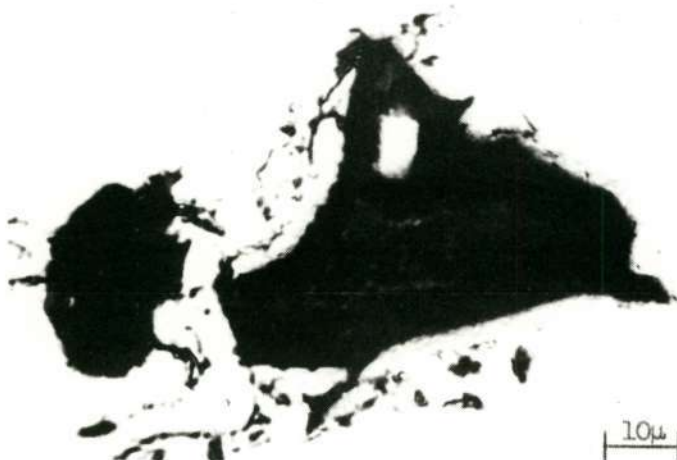
c. Plastically Strained
26 Percent

Figure 15 Voids in the Centers of Tensile Specimens of
Commercial AISI 4340 Plastically Strained

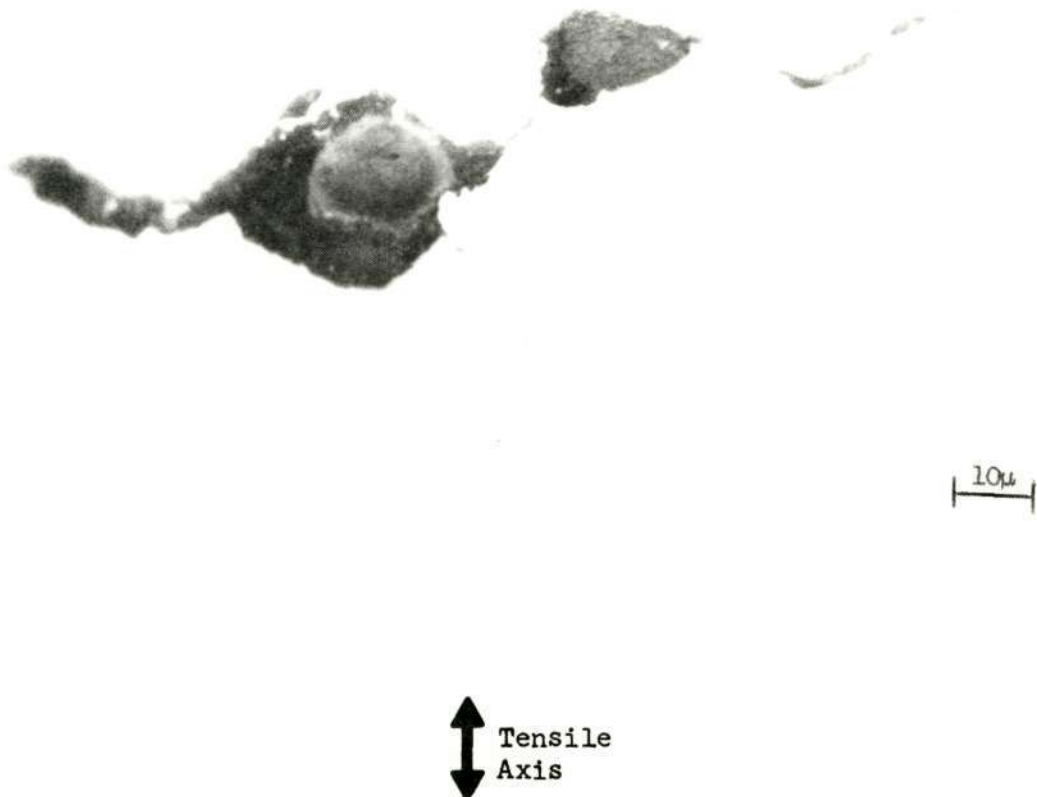
Figure 22 Coalescence of Voids by Cracking in Commercial AISI 4340
Plastically Strained 25 Percent

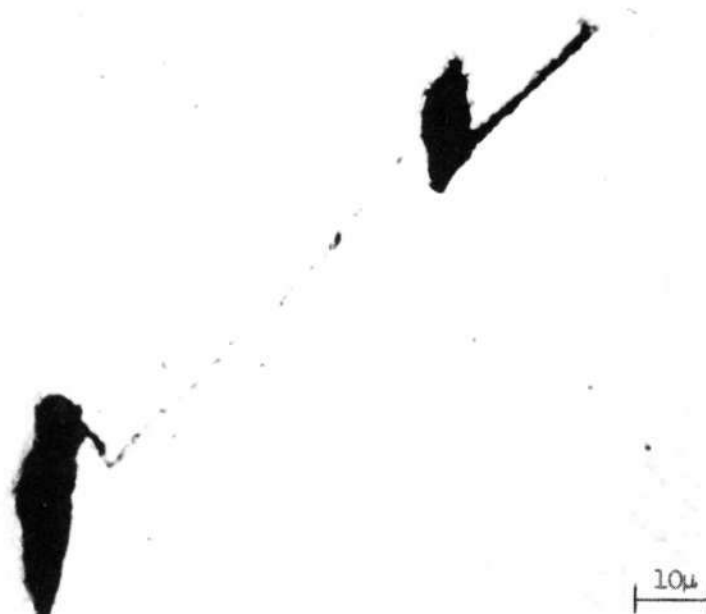
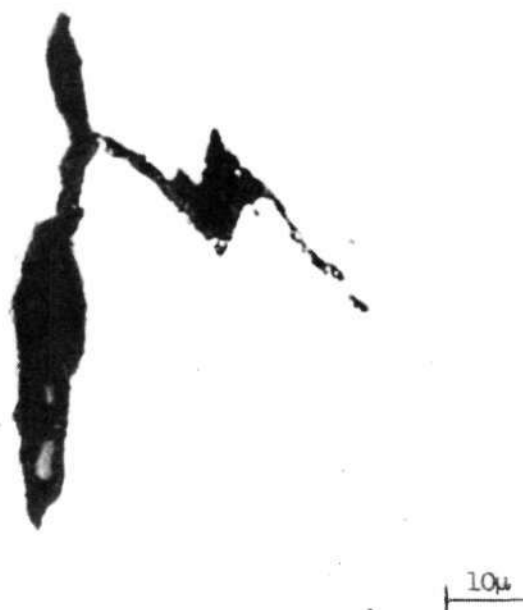
a. Plastically Strained 25 Percent

b. Plastically Strained 27 Percent

Figure 23 Coalescence of Voids by 45° Cracks in Commercial AISI 4340 Plastically Strained

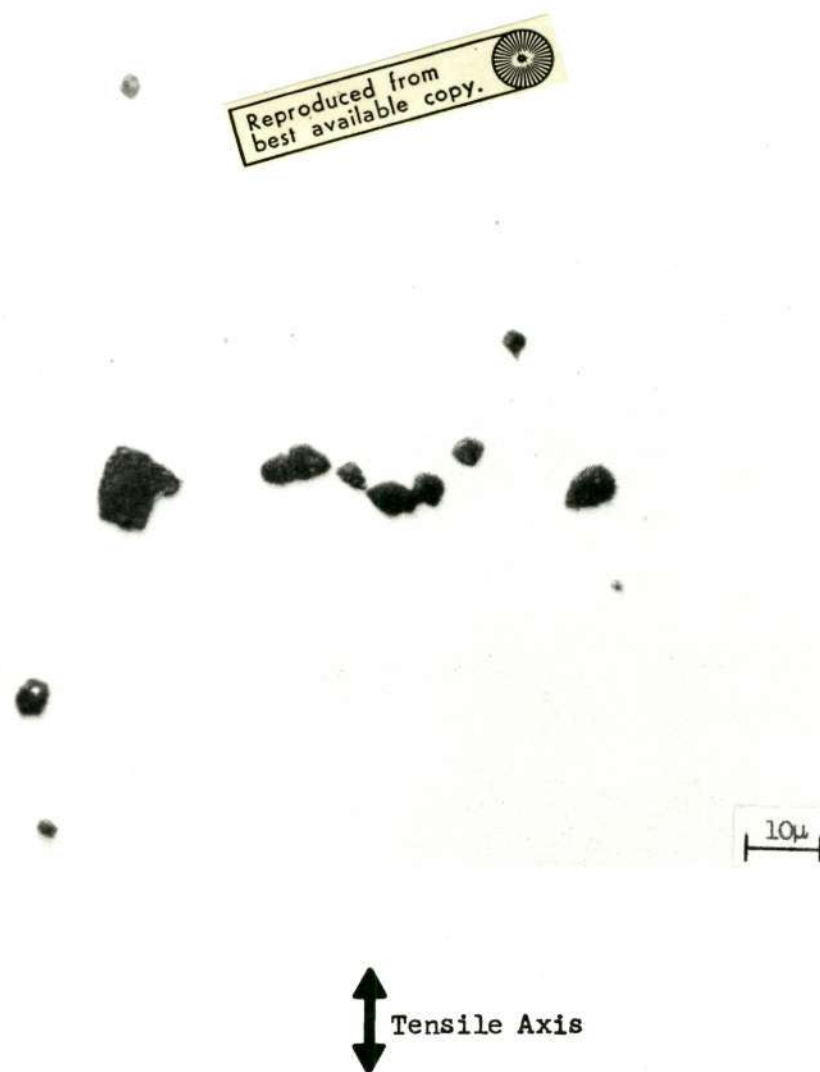
Figure 25 Void Coalescence in High Purity 18 Ni Maraging
Plastically Strained 81 Percent

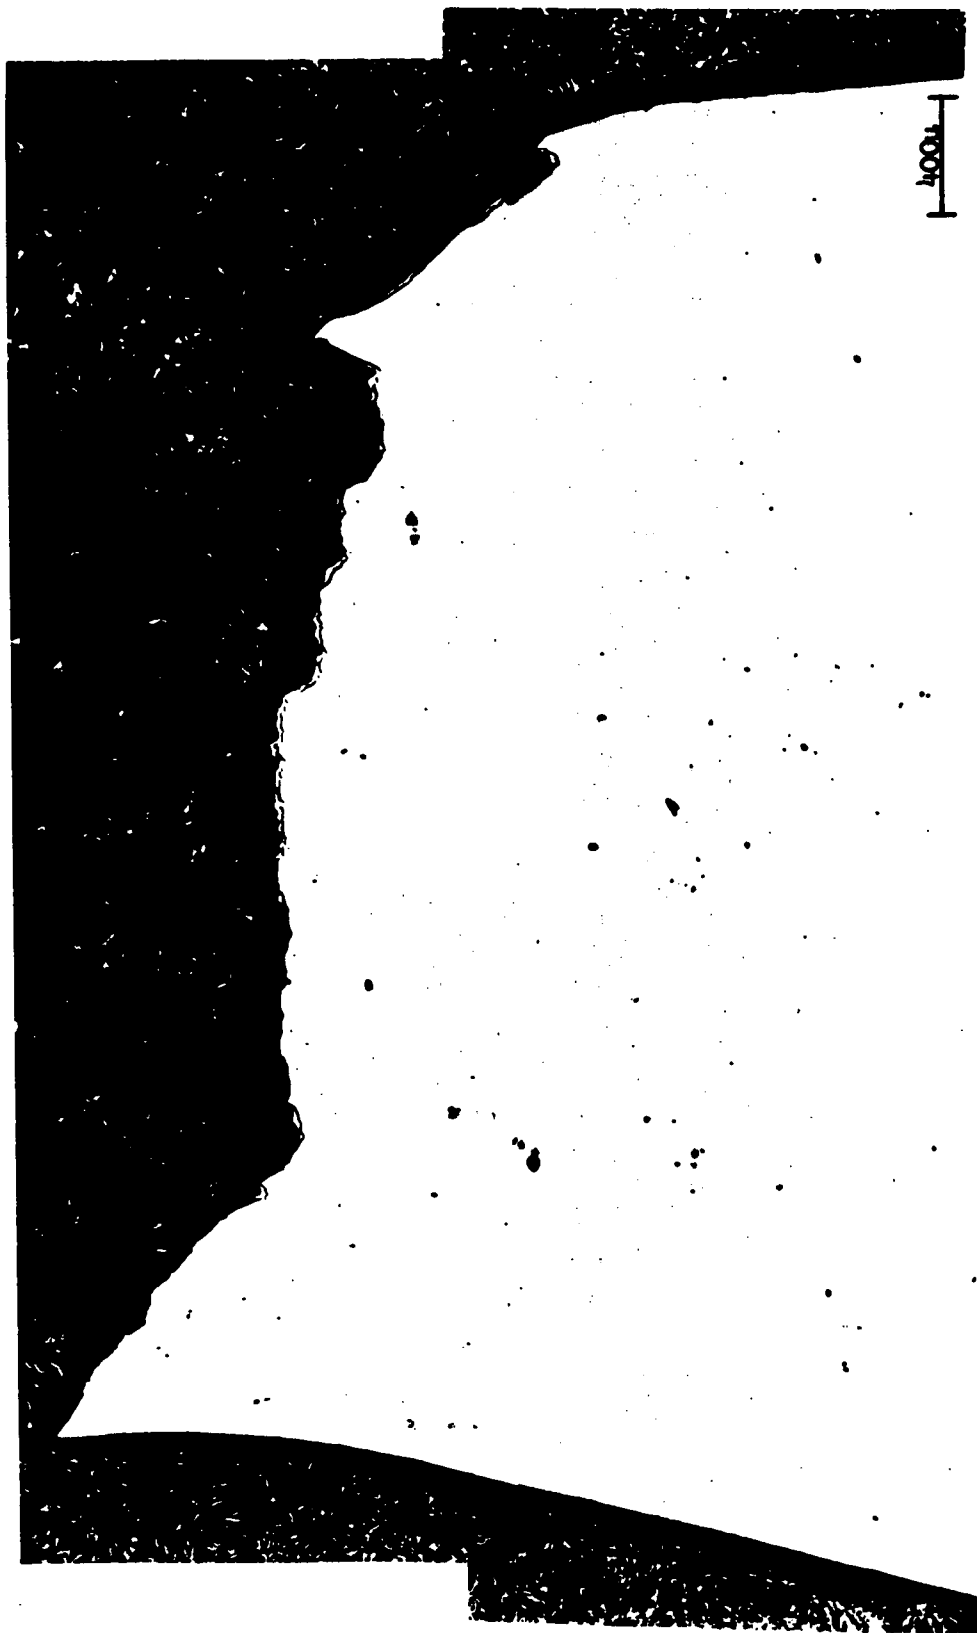
Figure 27 Midplane of Fractured Tensile Specimen of Commercial AISI 4340 ($\epsilon = 0.288$)
